## 2. Flood Dynamics in the Biocultural Puuc Region

### 3. Biocultural Context and Micro-Basin Management Using LiDAR and GPR

#### 4. Methodology.

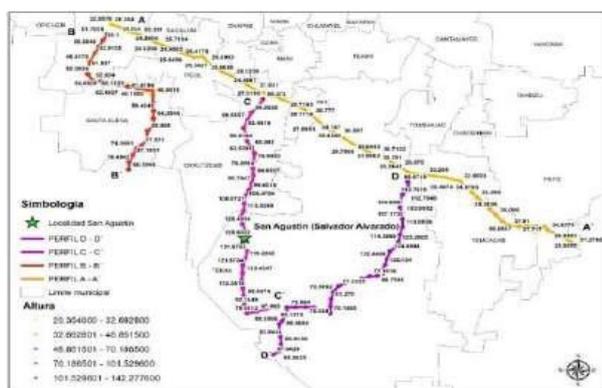
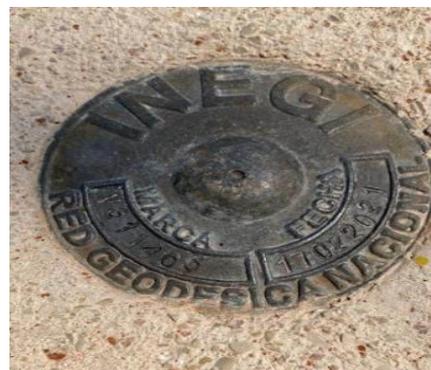
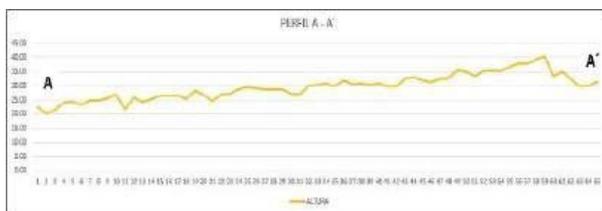
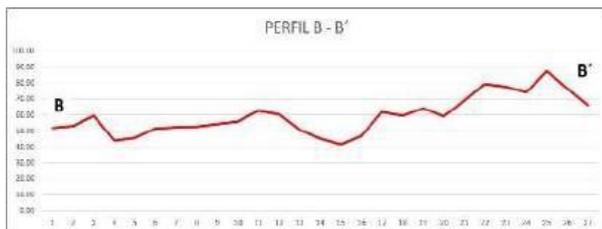
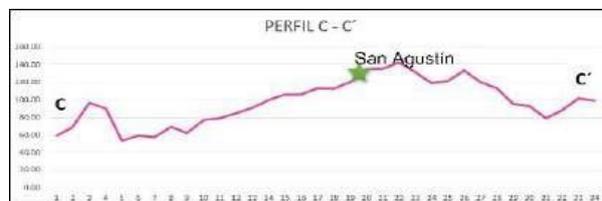
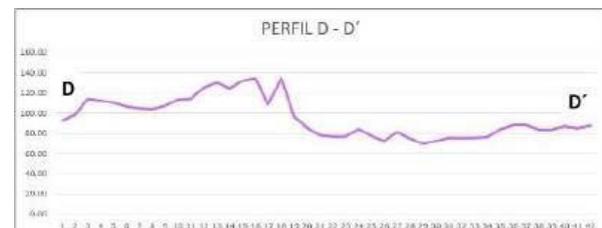
**Figure 2.** Topographic profiles of the Biocultural Puuc Region. Each point represents the location of a physical plate containing data and records from INEGI (2022). Altitude values are referred to as mean sea level.

The terrain elevation ranges from 50 to 180 meters higher than in the northern peninsula, with some very steep slopes. Figure 2 shows the national geodetic data network marked in meters above sea level (INEGI, 2022), along the most important communication routes in the Biocultural Puuc Region. Below it is the topographic cross-sections in the NW-SE direction (A to A') and three general NE-SW cross-sections. These clearly illustrate the higher elevation of the terrain and its subsequent drop to the SW, forming a watershed dividing two micro-basins: Salvador Alvarado (Ejido de San Agustín) to the NE, and Chan Dzinup – San Isidro Yaxché to the SW (C to C').

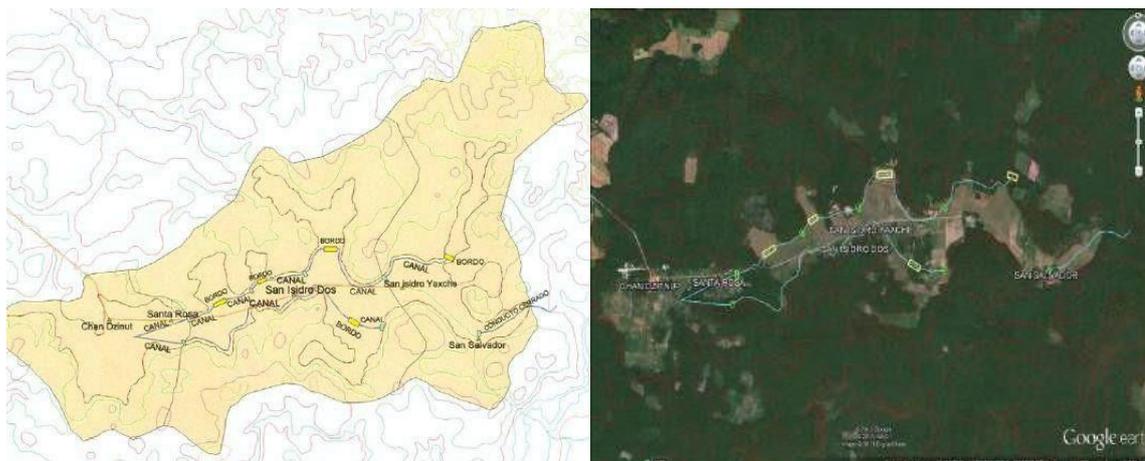
**Figure 3.** Location of surface works in the Chan Dzinup basin.

Espinosa's study recommended surface infrastructure to control flooding, such as containment dikes and diversion canals or drains, shown in Figure 3. These drains correspond to the lowest part of the micro-basin. This framework also helps describe the functional middle and upper parts of the hydrological micro-basin.

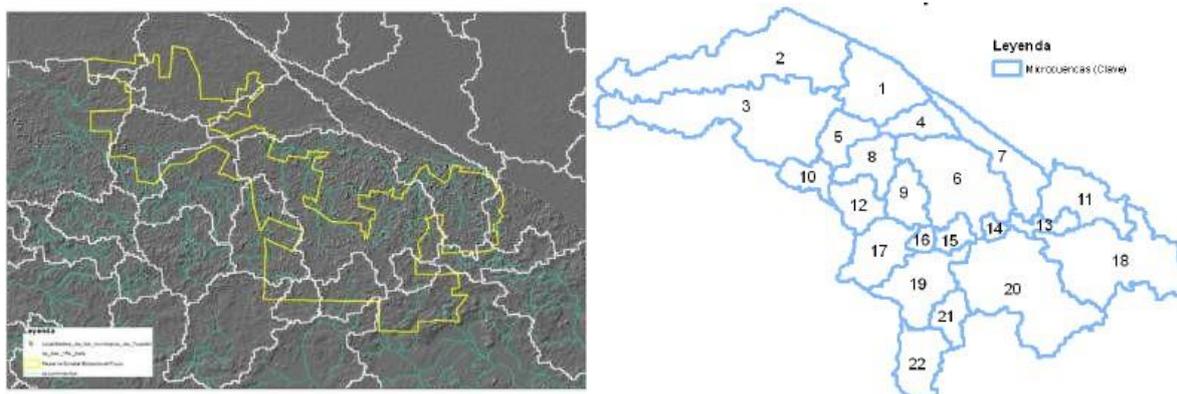
**Figure 4.** Micro-basins derived from the digital elevation model and presence of surface runoff in the Biocultural Puuc Region.

The work by Hernández et al. (2011) presents an interferometric radar image of the Yucatán Peninsula relief, used to generate a digital elevation model (DEM) via the USGS Hydrosheds online tool (<http://hydrosheds.cr.usgs.gov/>). This model allows the identification of local depressions that can be considered micro-basins associated with the small surface runoffs in the Biocultural State Reserve of the Puuc and surrounding areas (Figure 4). Using this information, 22 micro-basins were delineated. These first-order geographic units were used to develop the Management Program for the Biocultural State Reserve of the Puuc, published in the Official Gazette of the State of Yucatán, Number 485, in 2022. The town of Salvador Alvarado in the San Agustín Ejido lies in the southern part of micro-basin 6.

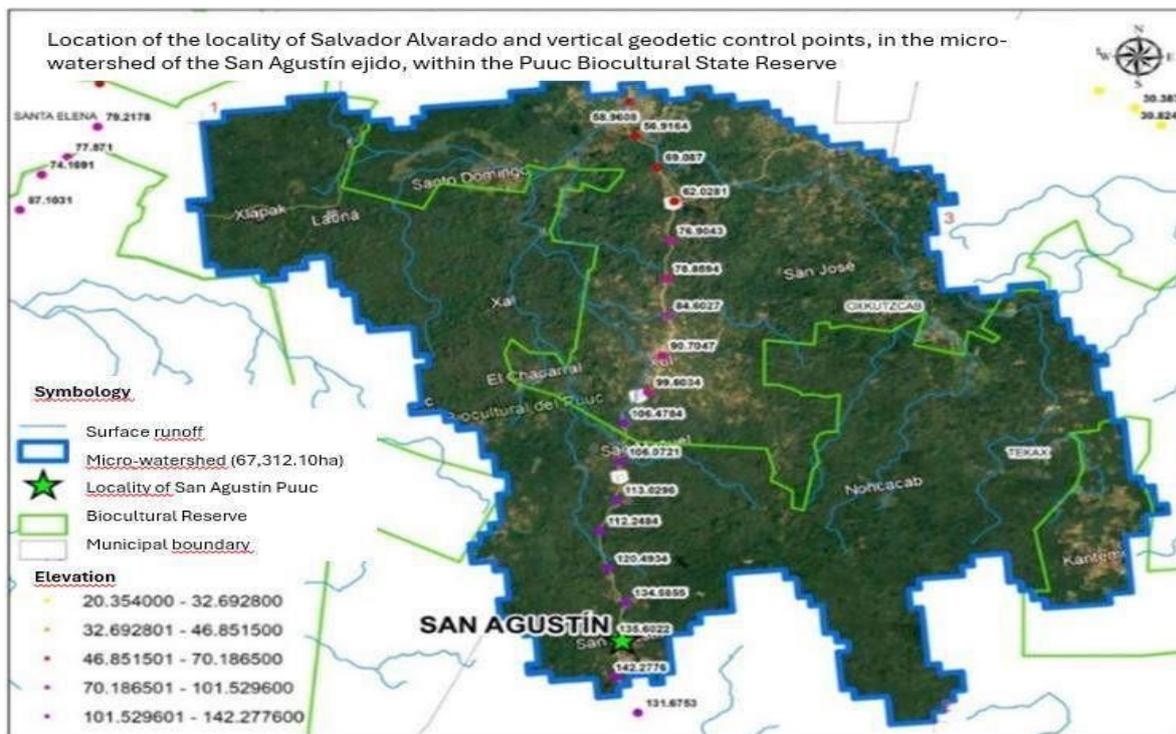
**Figure 5.** The town of Salvador Alvarado in the San Agustín Ejido is located at the highest part of micro-basin 6.

These landscape units are described in Figure 5, showing the boundaries of micro-basin 6 of San Agustín and the location of Salvador Alvarado to the south, with a total surface area of

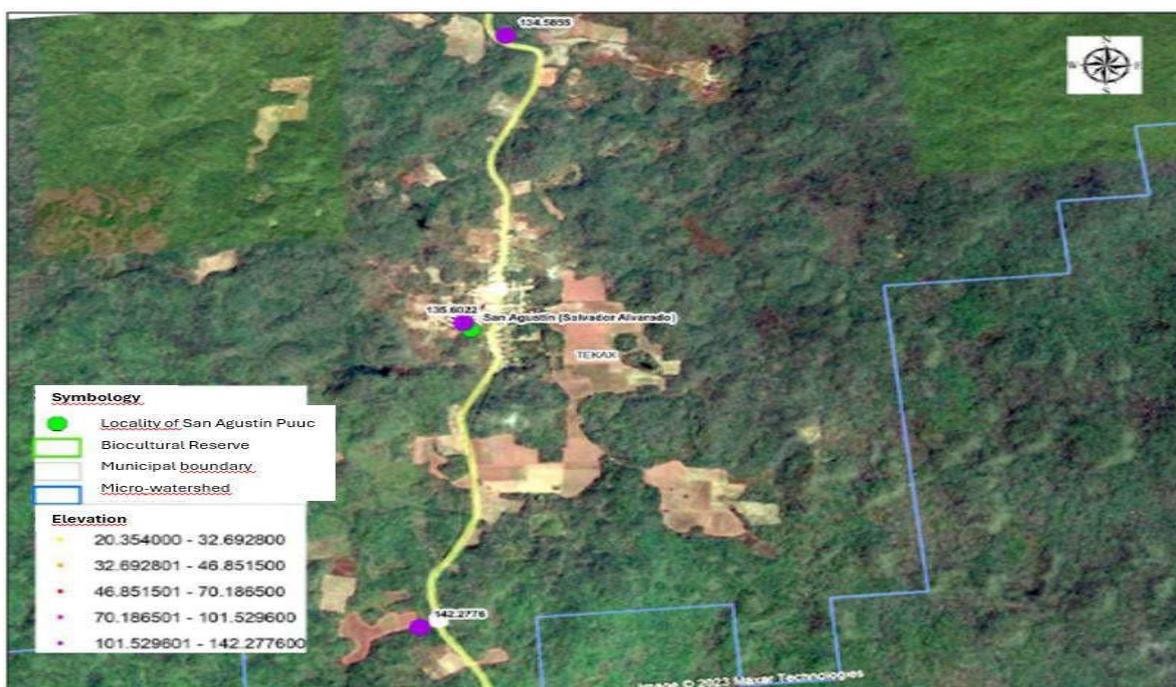
**Figure 6.** The image shows the boundaries of Micro-basin 6 (blue line) and purple topographic points from INEGI (2022) along transect C to C' on its southwest edge. The central purple point in the yellow box corresponds to an INEGI plate located at the multipurpose sports court in the urbanized zone of Salvador Alvarado.

Ejido is shown in Figure 6, where the micro-basin (yellow box) of the central transect (point C to point C' from Figure 1) is located.

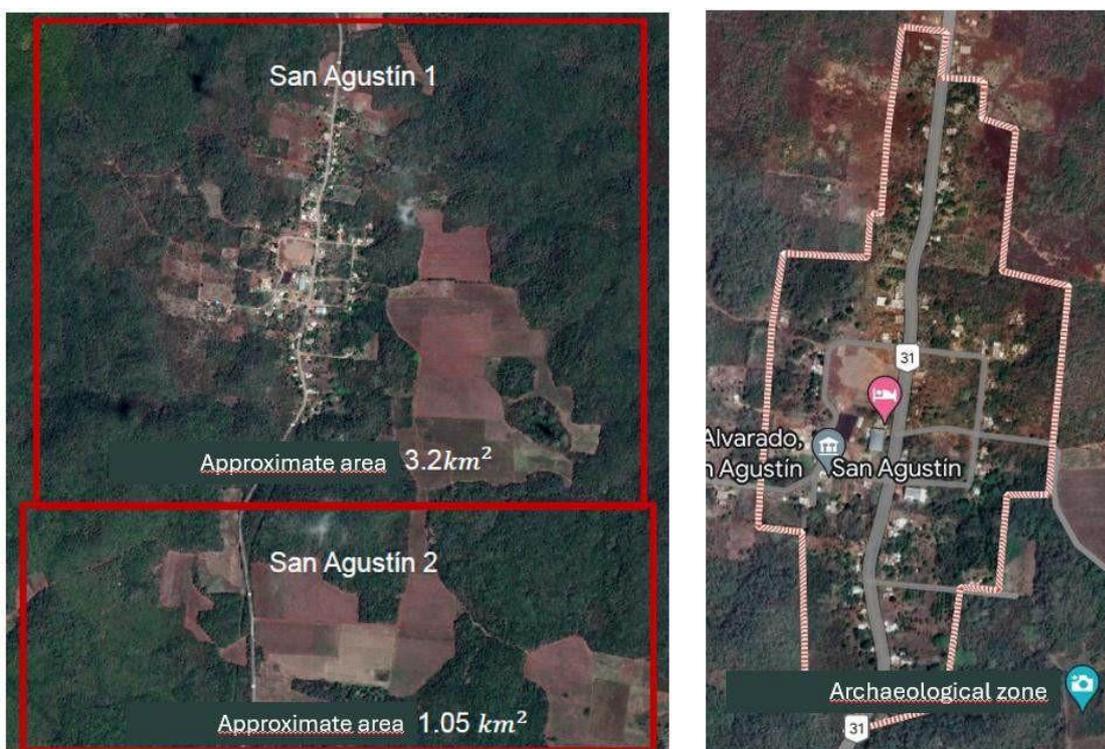
**Figure 7.** Sectorization of the facies basin for study purposes. Sector 1 and Sector 2 (4,250,000 m<sup>2</sup>). The urban area of Salvador Alvarado is outlined on the right.

The LIDAR acquisition and orthophoto mosaic were divided into two sectors, which are shown in Figure 7.

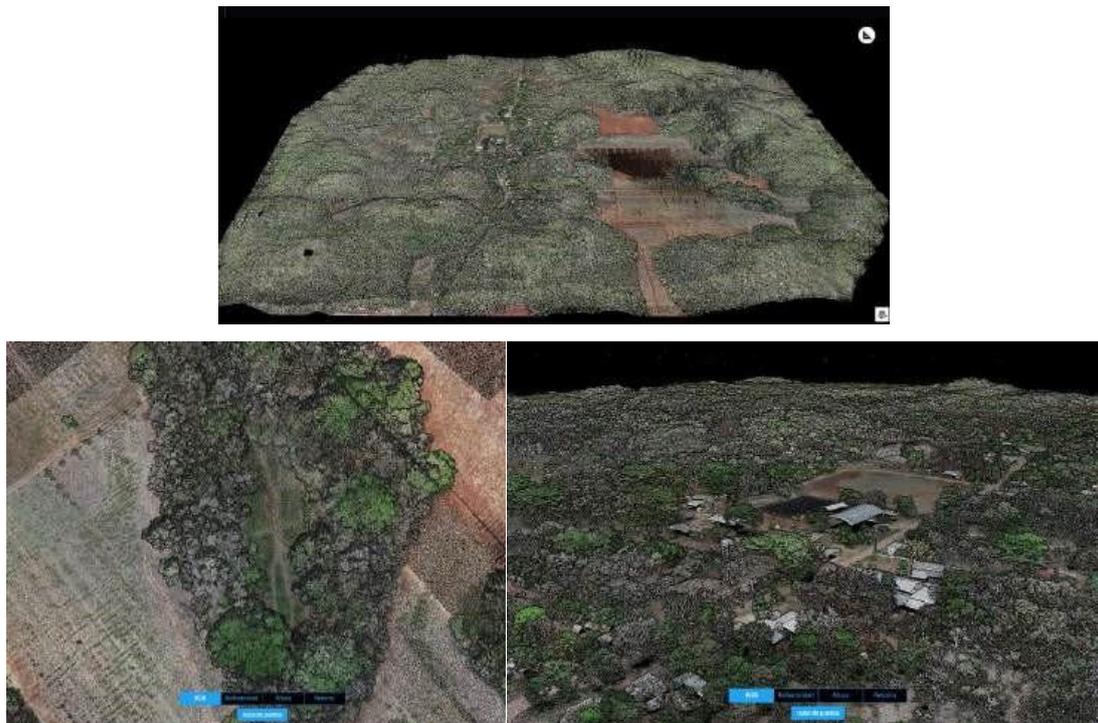
**Figure 8.** San Agustín Sector 1, point cloud view, colored with RGB.

The point cloud reconstruction is presented below, colored with RGB (Figure 8). Centimeter resolution allows for more precise analysis of structures. The orthophoto and intensity maps are

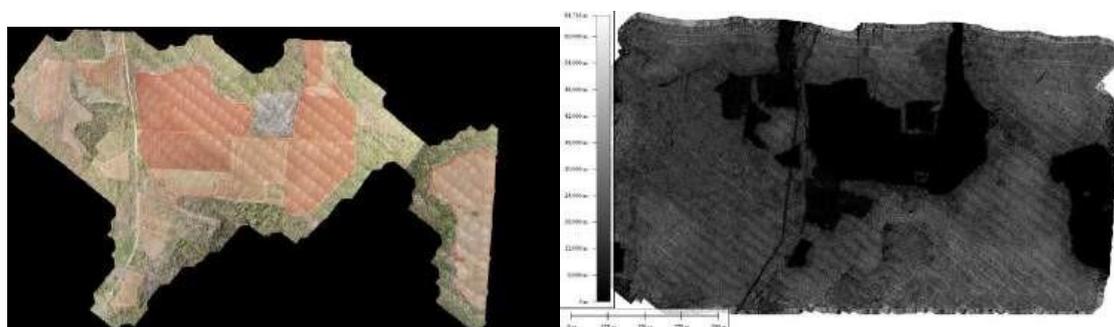
**Figure 9.** San Agustín Sector 2, Development of orthophoto and intensity map.

developed (Figure 9). From this, the digital elevation model is developed (Figure 10).

The intensity map represents feedback information from laser light reflected by objects on the surface. It can be useful for vegetation analysis, terrain modeling, object identification, planning, and more.

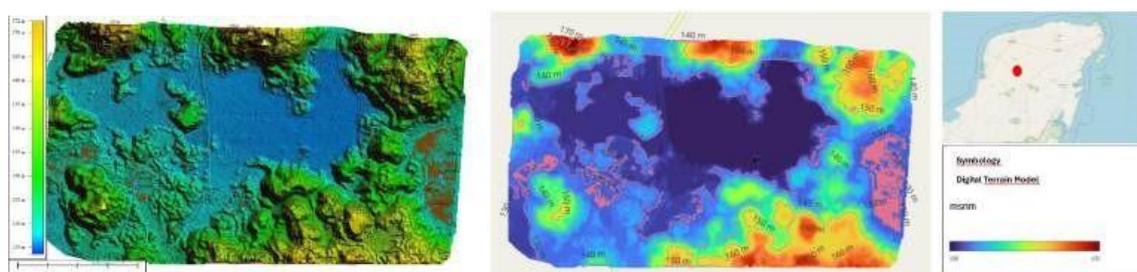
**Figure 10.** Digital terrain model (DTM) of the San Agustín Sector 2 segment with contour lines. Two representation methods.

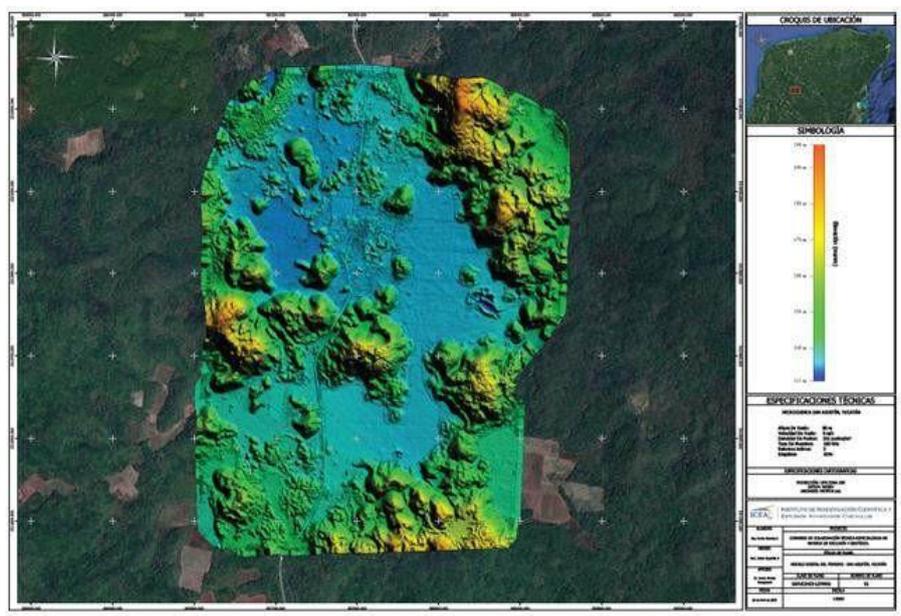
**Figure 11.** Lidar image of the facies basin of the town of Salvador Alvarado, San Agustín Ejido (Total image area: 3,962,354.72 m<sup>2</sup>).

The result is a lidar image of the town of Salvador Alvarado in the San Agustín Ejido (Sectors 1 and 2), representing the facies basin at the minimum elevation of 132 meters above sea level

and the maximum elevation for overflow and runoff at 137 meters above sea level (Figure 11).

In this last image, in the central-eastern area, a structure known locally as "Aguada" (yellow contour box) can be seen. It is composed of at least 3 depressions or regulating vessels with banks almost 2 meters high above the plain terrain, at more than 5 meters of total depth, and which allow the containment of temporary surface runoff water from the slopes that surround it to the east and are drained through channels that can be seen to the east of the aguada, as clearly seen in the following Figure 12. The origin of this structure is unknown; it is unique in this facies basin.

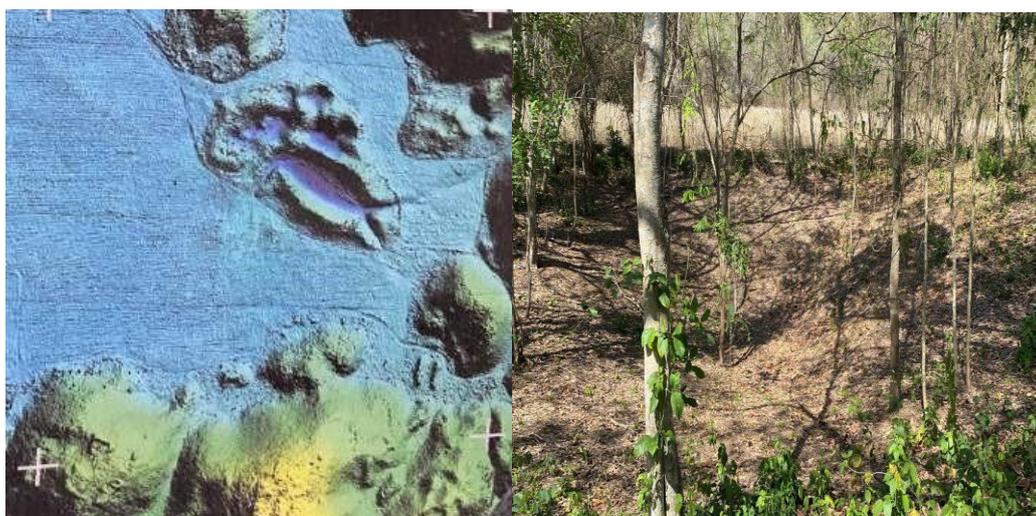
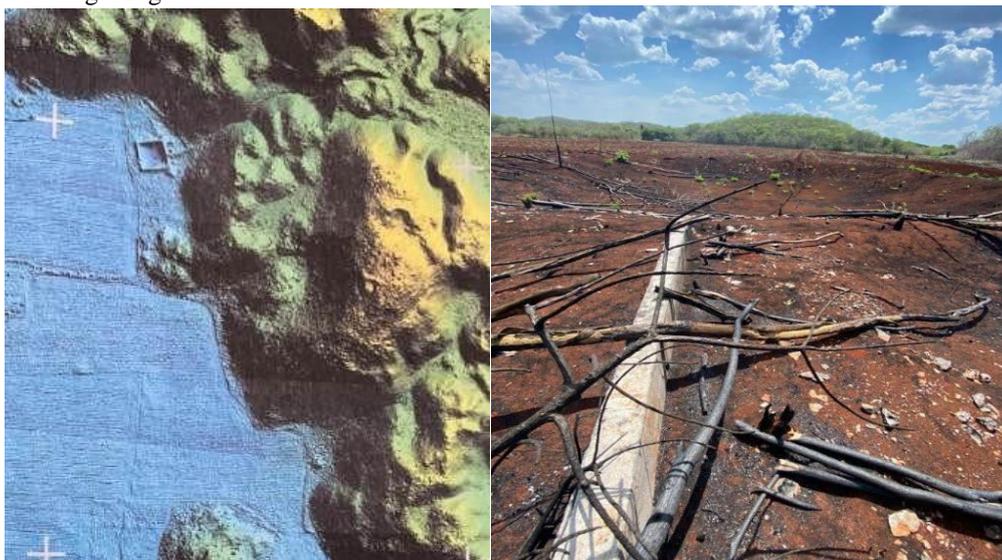
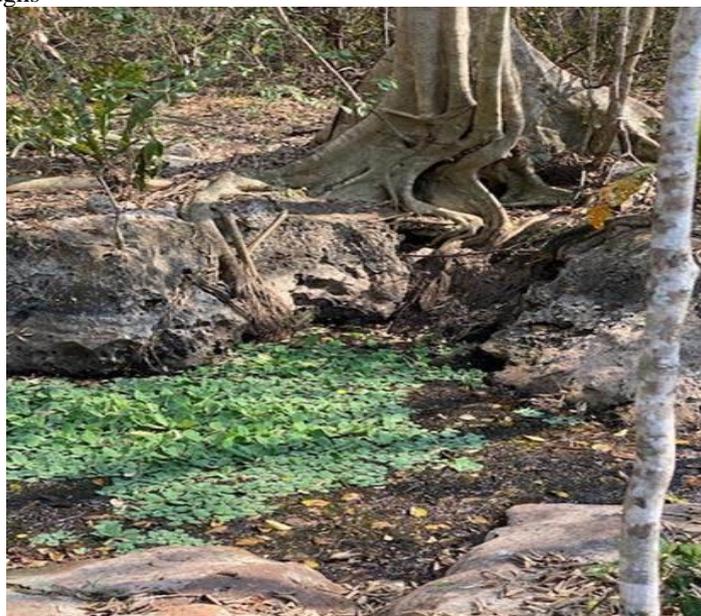
**Figure 12.** Various water control structures, the first known as an aguada (watering hole), the second a square livestock watering trough, and the third a sartenejas (watering pan).

There are two other small watering holes, but these were built as livestock watering troughs. They are much smaller in size and feature a small dam constructed of stones of various sizes covered with soil derived from the excavation inside the trough to capture runoff water from the eastern slope.

Small depressions known as "sartenejas" (watering pans) also appear as containers in the limestone rock. These are flooded during the rainy season, and the water remains in them for several months, or until the next rainy season (Figure 12).

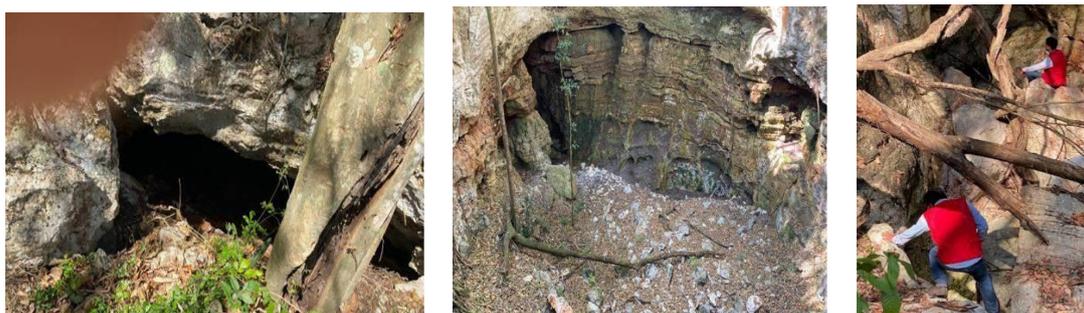
**Figure 13.** A hollow-type karst structure or cavern-type karst structure, locally known as "Xuuch."

Various xuuche-type karst structures are also found in the eastern and northern portions of the facies basin (Figure 13). These often feature vertical drops of more than 30 meters, where surface water flows, carrying large quantities of stones and logs.

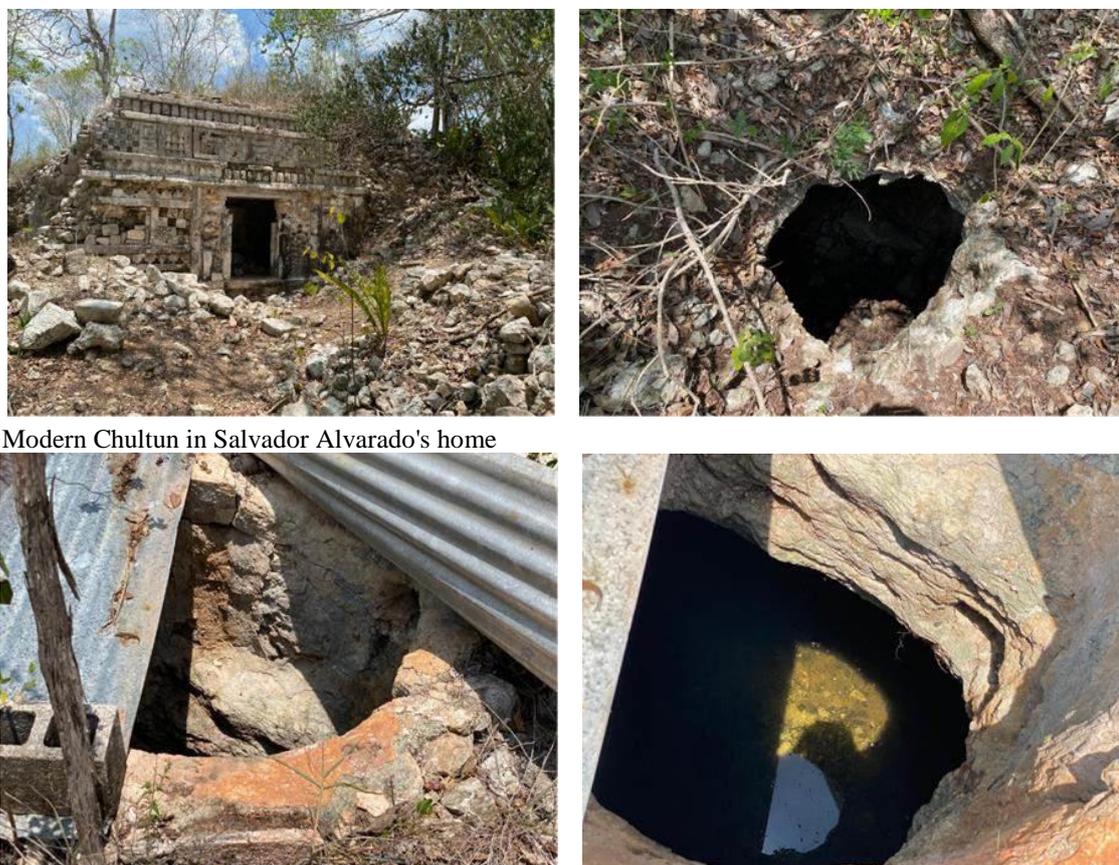
**Figure 14.** Ancient and current forms of water management for family and household consumption, Archaeological Sites and Ancient Chultún.

Modern Chultun in Salvador Alvarado's home

human consumption and religious practices by excavating a type of waterproofed cistern called "Chultún" in the rock, which is still used by ancient families (Figure 14).

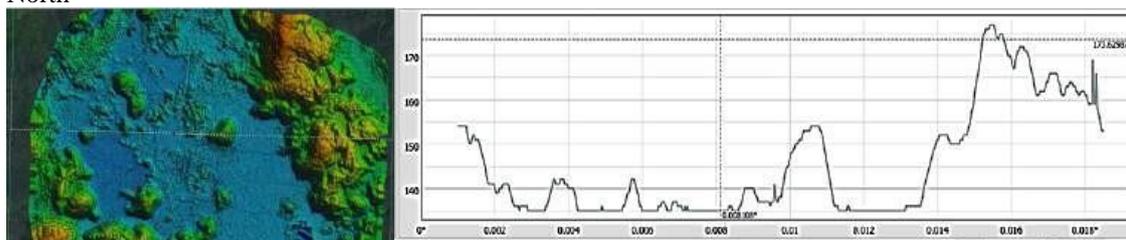
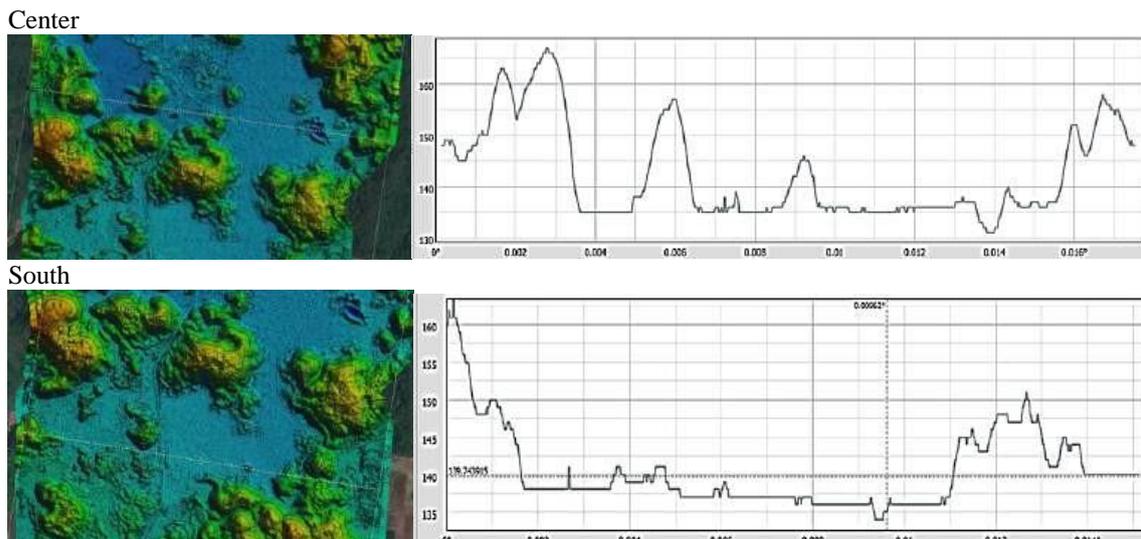
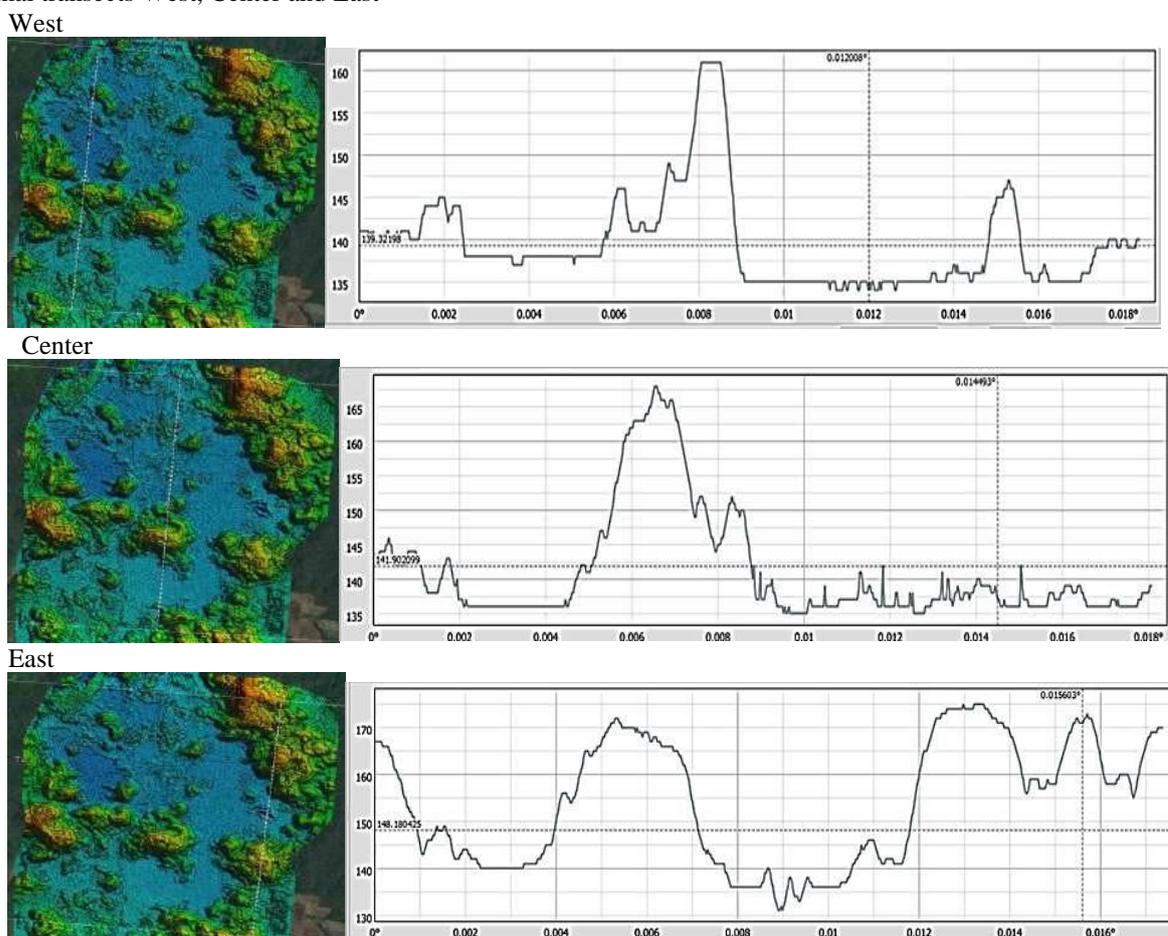
**Figure 15.** LIDAR image results and elevational variation within the basin facies.

a). North, Central, and South transects.

b). Longitudinal transects West, Center and East

Figure 18 presents the results of the vertical (longitudinal) and horizontal (transverse) elevational variations of the basin facies. As can be seen, all of them show significant elevations at the extremes, leaving an extensive plain with minor elevational variations in the center. It is evident that the most evident depression is the "Aguada" basin, with an elevation of 132 meters above sea level.

The middle basin develops from 137 to 140 meters above sea level, and the upper reaches reach over 160 meters above sea level, with the eastern zone presenting the highest elevations of almost

180 meters above sea level. Also notable is the presence of a slope of the plains that run from the south at 140 meters above sea level to the north at 132 meters above sea level, a drop of almost 8 meters.

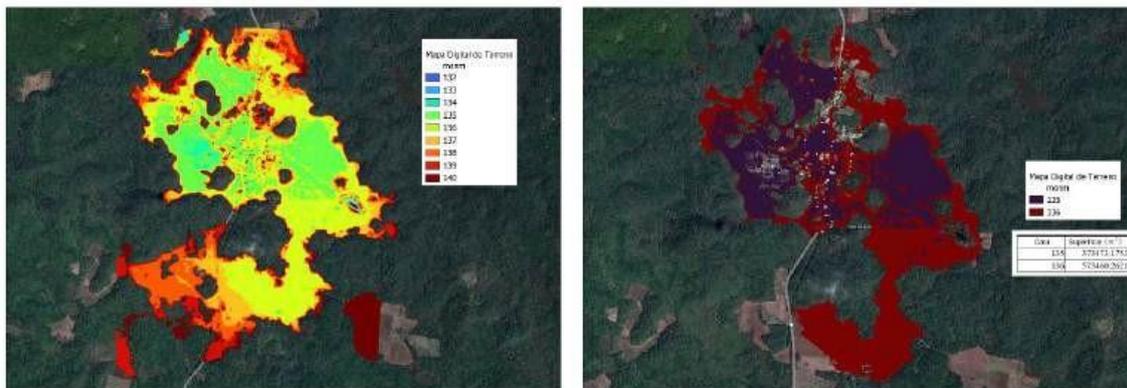
**Figure 16.** Surface extension of the various topographic heights of the 132 masl facies basin and the 140 masl elevation, and the accumulated surface extension for the 135 and 136 masl elevation, called the lower basin, is detailed.

The area of the sub-basin between 135 and 136 meters above sea level can be considered the main extension representing the functional zone of the lower basin (elevation of 132 meters above sea level in the watershed to the level of 136 meters above sea level) and extends over 96.89 hectares (representing 24.45% of the total lidar image). The probable start elevation of flooding is 137 meters above sea level, as seen to the north of Figure 16,

and which extends over a cumulative area of 121.14 hectares (Table 1). According to Figure 16, with flooding greater than this topographic elevation, water would begin to overflow in the north of the facies basin toward the runoff from the upper part of Micro-basin 6, described above. This gives an idea of the surface water storage capacity that this facies basin could contain.

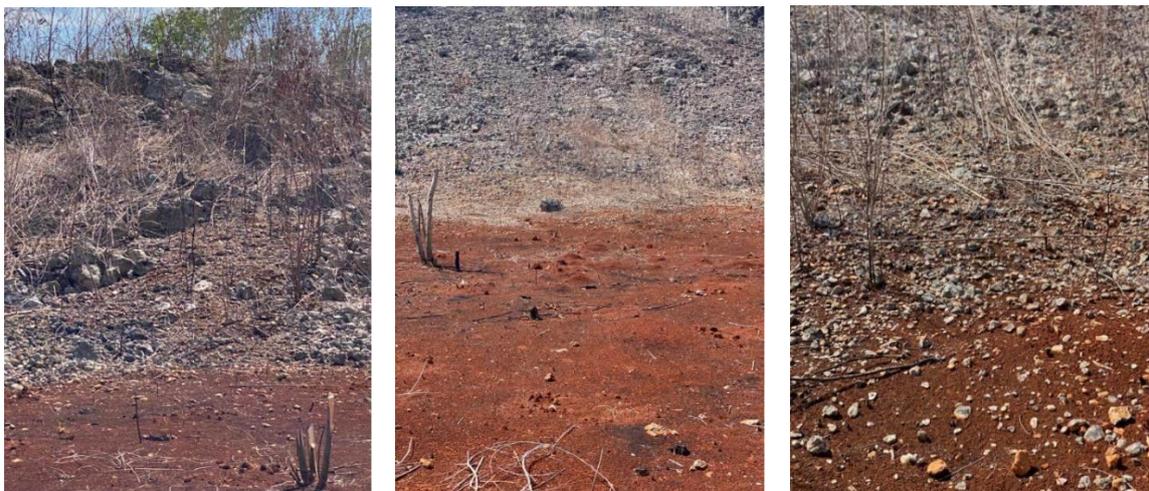
**Figure 17.-** Hills devoid of vegetation to the north of the facies basin, in the town of Salvador Alvarado (Ejido de San Agustín), where the Leptosol – Luvisol soil catenary can be observed, according to the altitude of the slope.

The soil distribution in this region is very peculiar, with a wide variety of soils found within a few meters (Figure 17). In a longitudinal or lateral profile, it is possible to observe that the higher elevations are covered with Leptosol-type soils, particularly lithosols, very thin soils. As one reaches the middle of the slope, the soil changes to rendzina-type soils, with thicknesses greater than 20 cm and a high presence of organic

matter. Finally, we reach the lowest area of the plain, where Luvisols, soils deeper than 2 meters, are found. This is where the structure of the "Aguadas," the Xuuches, the agricultural fields, and the urbanized area are located. This coincides with the high elevation difference of up to 50 meters between the plains and the countless isolated domed hills distributed above them, creating a strongly undulating landscape. This generates a series of temporary surface runoffs that reach the flat terrain of the steep hillsides. Currently, this area is dedicated to corn farming, as well as some extensive cattle ranching, which takes advantage of the secondary associations of wild vegetation resulting from leaving cornfields that have been cultivated for two or three consecutive years fallow. These lands have potential for agricultural and forestry.

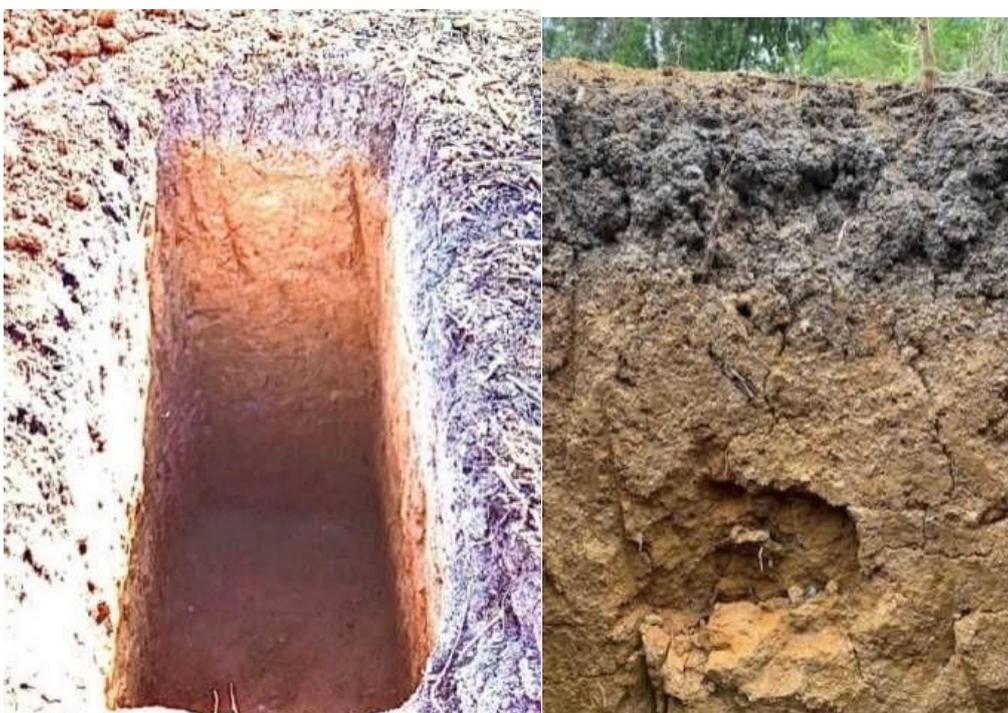
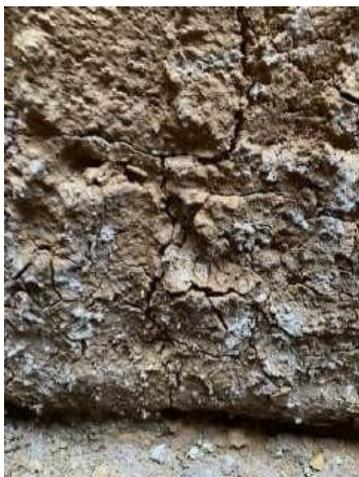
**Figure 18.** Beacon number 1 natural waterhole. Geographical position: 19° 58'32.1" N and 89° 28'54.5" W. Depth: 2 m. Excavation sequences and profile characteristics.

Fracturing of dry soil and formation of calcium salts at the bottom

A soil profile was created within the pond where the four GPR profiles meet. (May 2023), as shown in Figure 9. It was carried out during the dry season. Figure 18 shows the 2-meter-deep soil profile, as well as details of the profile showing the clayey nature of the material, with a slightly dark layer as Horizon A, with some organic matter derived from periods of flooding and drought. This is accompanied by a Horizon B present in the first 2 meters of depth, reaching the bottom with significant fracturing of the clay, with the formation of calcium salts.

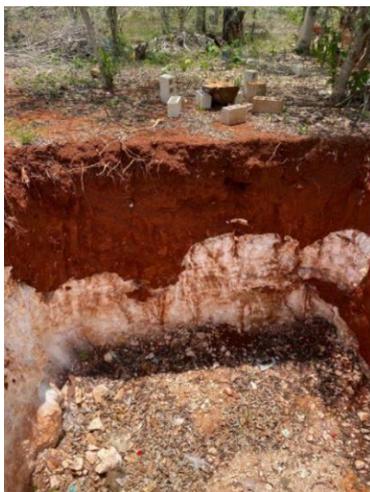
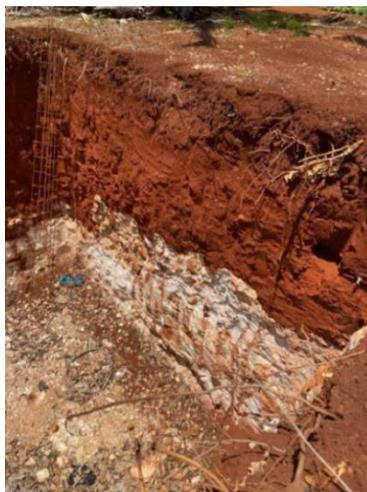
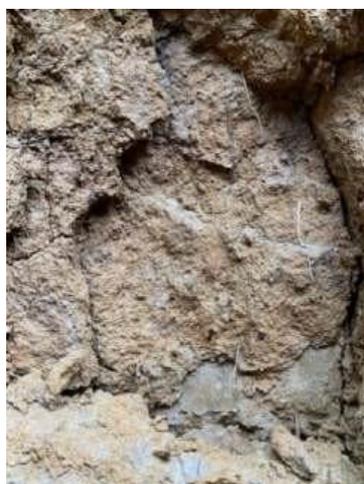
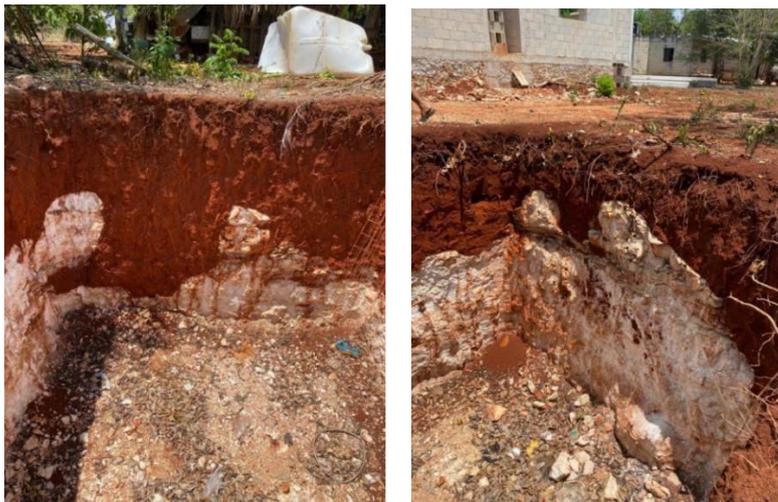
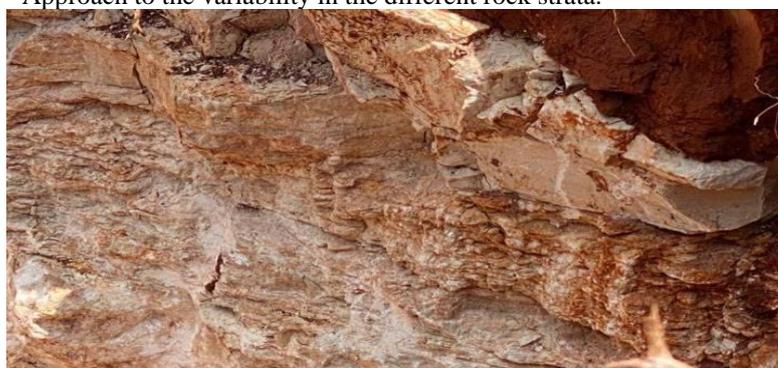
**Figure 19.** Four-view sections of the site with soil and rock profile. Municipal Commissioner's House. Geographical Position: 19° 58'36.0" N and 89° 29'17.4" W.

Approach to the variability in the different rock strata.

At the Municipal Commissioner's House in the town of Salvador Alvarado (Ejido de San Agustín), there is a soil and geological profile section measuring just over 4 m. Its location is shown in Figure 9. **Figure 19** shows the soil profile in the first 2 meters, which represent Horizon B, a primarily clayey soil with a highly

eroded and scarce layer of organic matter in the top few centimeters, leaving Horizon A very small.

Below a depth of 2 meters, what is identified as Horizon C is the calcareous rock that underlies the mineral soil, as shown in Figure 19.
